## Shipcare Rapid Response

Stone Marine Shipcare dispatched a six man service team to QingDao Beihai Shipyard, China, to carry out back-to-back propeller repairs on two Danish bulk carriers that had sustained ice damage.

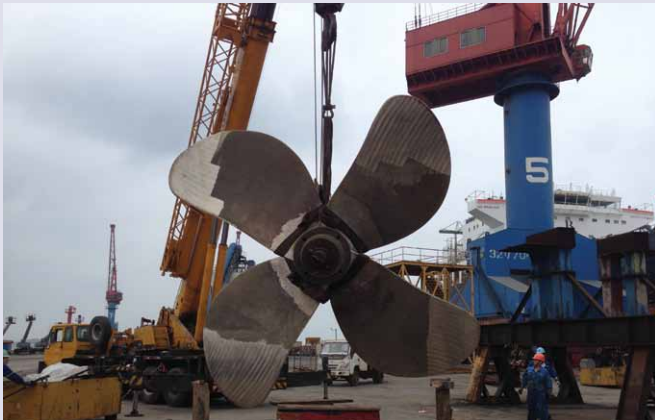
A Stone Marine Shipcare Service Technician had attended both vessels in Canada, prior to the dry docking, to carry out the necessary measurement afloat in order to manufacture new replacement tip sections.

In total, six large tip pieces were positioned and welded back into place following Class approved repair procedures previously presented.

Both propellers were re-tipped, a post weld heat treatment (PWHT) cycle carried out and balance tolerances checked.
