Stone Marine Shipcare (SMS) was contacted by an owner with 2 tips missing from a 6 metre diameter propeller. An experienced Service Technician was immediately dispatched to the vessel in Canada to survey the damage. Whilst the vessel sailed to Europe, a pattern was CNC milled and 2 new CMA1 special alloy tips were cast and airfreighted to Portugal within the week.

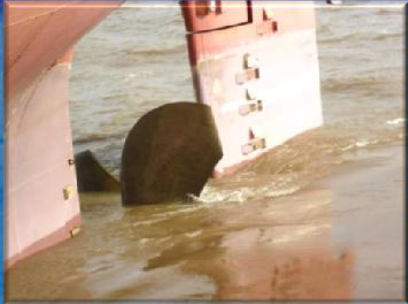
Visual Survey on Arrival.

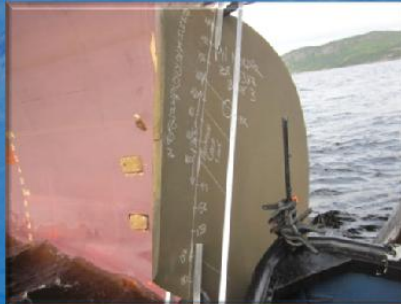
Measurements Taken Afloat.

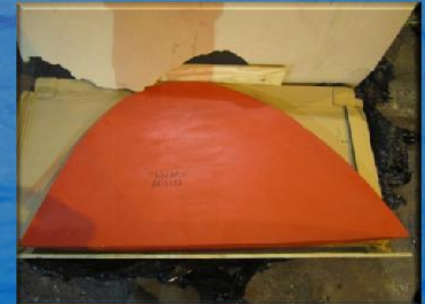
CNC Milled Foundry Pattern.

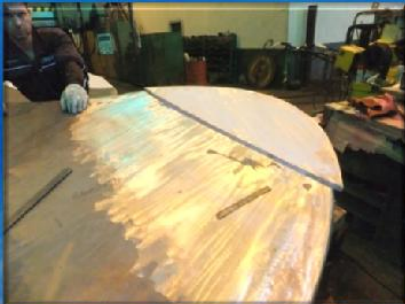
New Tip Piece in Place.

Service Technicians from the UK worked around the clock to complete the weld repairs in record time.

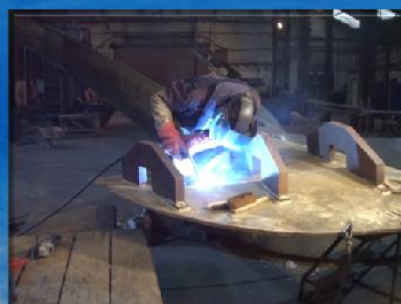
SMS Welding in Portugal.

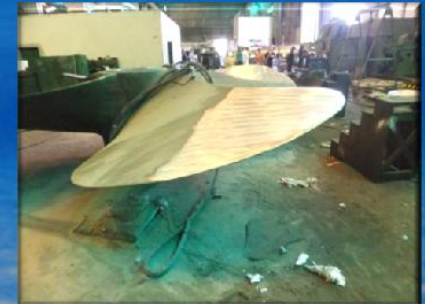
Completed Tips before Polish.

After repairs and post weld heat treatment, the vessel returned to service with the propeller at optimum efficiency.
