PANAMA PROPELLER REPAIR

The vessel involved, a 74000 DWT crude oil tanker, had suffered extensive propeller blade damage when, in bad weather, the vessel became entangled with a buoy.

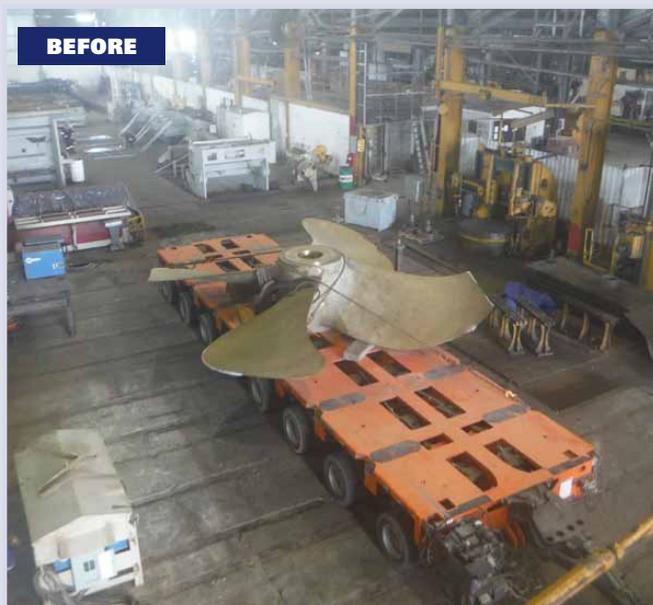
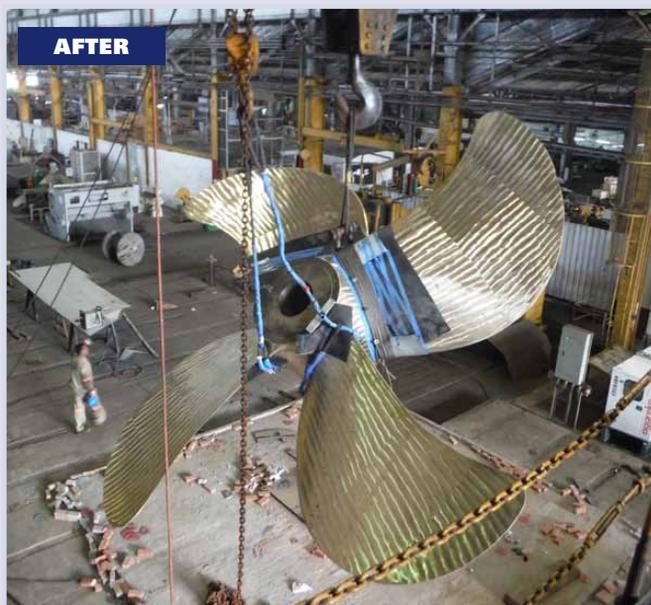
A job well done

After super polishing and balancing, the propeller was back in service well within the schedule.

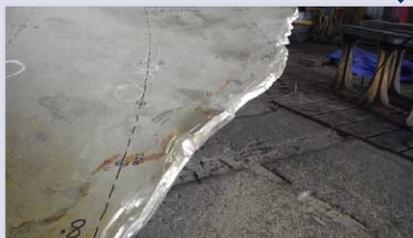
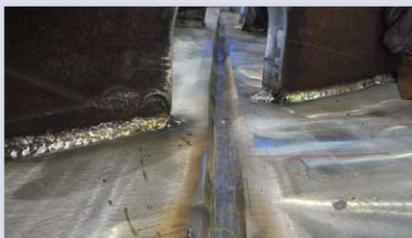
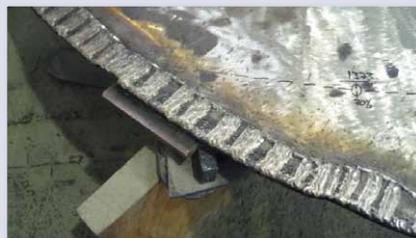
The extensive propeller blade damage

During the initial examination the damage caused was obvious and it was going to require the replacement of two large tip sections and extensive leading edge weld build up. For various technical reasons it was recommended to the vessels owners that after repairs had been carried out the propeller should be placed into a temperature controlled furnace for a full propeller post weld heat treatment. A process which, our engineers advised, was necessary to ensure the propeller was returned to first class condition and could face the future with certainty.

The propeller was removed from the shaft with the vessel still afloat and transported to a workshop in Panama. A full propeller measurement survey was carried out to establish the magnitude of the bend damage plus a complete NDT package to ensure all linear defects were found and removed.

Replacement tip sections were 3D modelled and manufactured within one week of Stone Marine Shipcare being informed that the propeller was in need of repair and were flown out to Panama.

Bend damage was straightened using Stone Marine Shipcare's own propeller measuring equipment to establish the correct blade profile and pitch.

The blades and new tip sections were prep'd, positioned and welded into place following Class approved procedures. All work was completed within the timeframe required.

A furnace large enough to accommodate the 7.2 metre diameter propeller was designed in the UK and manufactured onsite. The heating elements and control electronics were flown out from the UK and the propeller was placed inside for a full heat treatment process.
